OFFENSE/ORS/ Fatal Motor Vehicle Collision

SUBJECT OF THIS REPORT/ Collision Reconstruction

**REPORT SUBJECT:** COLLISION RECONSTRUCTION

**LOCATION:** State Route 58 (SR) and Crestview St. (CS) MP 35.48, Oakridge, Lane County, Oregon.

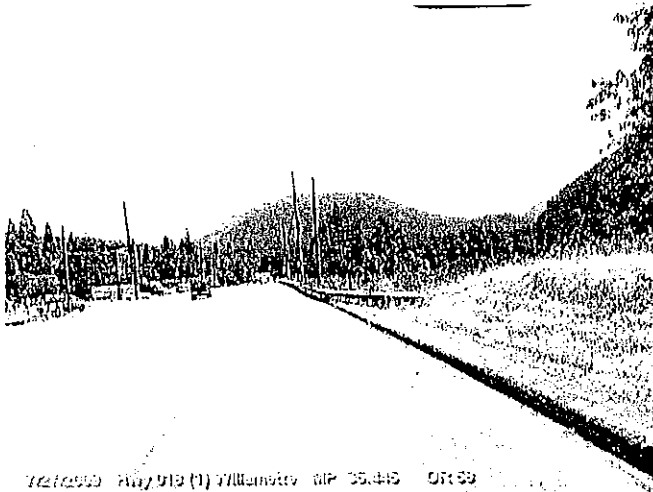
Traveling eastbound on State Route 58 there is approximately 730 feet of minimum clear visibility to the east to observe oncoming traffic flow. The pictures below depict the minimum sight distance. The eastbound photograph was taken from mile point 35.445 approximately 315 feet prior to the intersection with Crestview Street. Continuing to the intersection, the distance of unobstructed view remains consistent. It is possible for an attentive driver to see greater than this distance. A downgrade and slight left to right curve in the roadway begins to restrict the visibility of oncoming vehicles beyond this distance. *(The photos were obtained from the Oregon Department of Transportation Digital Video Log).*

(Eastbound view from B-lane)

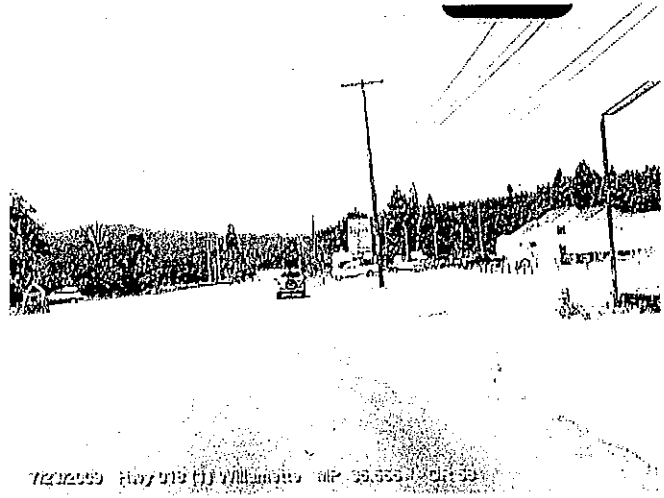
(Westbound view from B-lane)

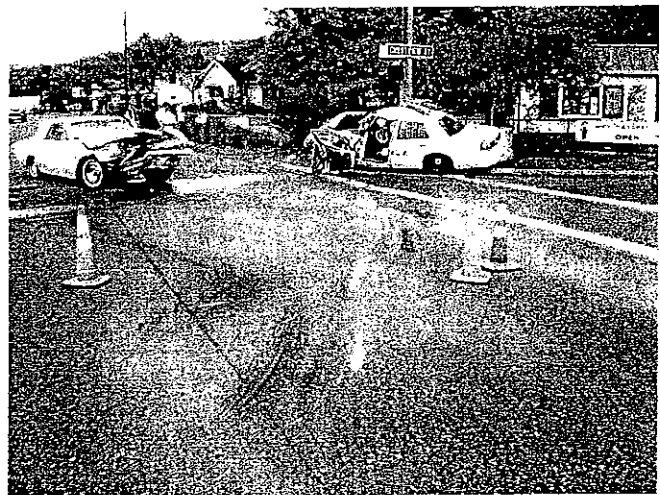
- Also within the area of impact (AOI) is a narrow tire scuff mark created by the deflated left front tire of Vehicle #2. The mark also has a directional component that shows the vehicle was redirected from left to right at impact. The mark is about 9 feet in length and then changes to a metal scrape mark that continues for an additional 14 feet. *(The narrow tire scuff mark was not mapped and is approximated in the diagram based on photographic evidence).*

- A metal scrape mark approximately 2 feet in length parallels the tire scuff mark created by Vehicle #2. The mark begins within the area of impact and leads towards the final uncontrolled rest position of Vehicle #2.

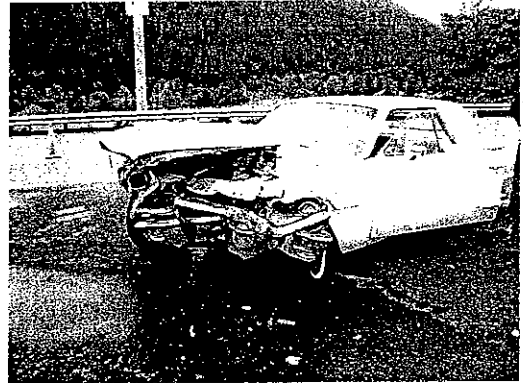
- Extensive contact damage across the width of the front of the vehicle. The damage penetration is greatest at the left front corner where the left front wheel was pushed rearward due to crush.
- The steering wheel is bent as a result of contact with the decedent.

Induced damage due to buckling is visible on the left side just behind the driver's door. A small area on the left rear quarter panel level with the drivers door latch was buckled inward.

The Principle Direction of Force (PDOF) for the impact traveled from the center left half of the front bumper to the area behind the left front wheel. The eccentric impact induced a rapid counter-clockwise rotation of the vehicle around its yaw axis.

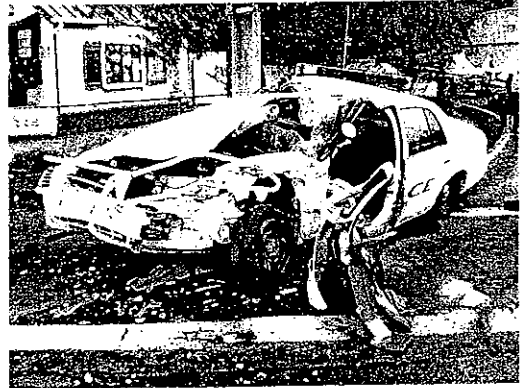
For the initial impact contact crush damage is present beginning at the center of the front bumper and extending to the driver's side door. The damage penetration is deepest at the left front corner. The left front wheel rim was damaged due to impact and the tire deflated. The left front suspension assembly was damaged, and the vehicle frame in contact with the pavement.

The PDOF for the initial impact traveled from the area of the left front corner toward the area of the right rear corner. The impact was slightly eccentric to the vehicle's center of mass and induced a gradual counter-clockwise rotation.

- Along the engine hood
- Across the roof
- The windshield shattered as a result of the buckling.

- Secondary contact damage is present on the passenger side of the vehicle where it impacted with the traffic light pole. The contact damage centered on the passenger side front door.
